NASA WG3 MMOD Protection Summary

33rd Interagency Space Debris Coordination Committee (IADC)
March-April 2015

Summary of MMOD Protection Activities

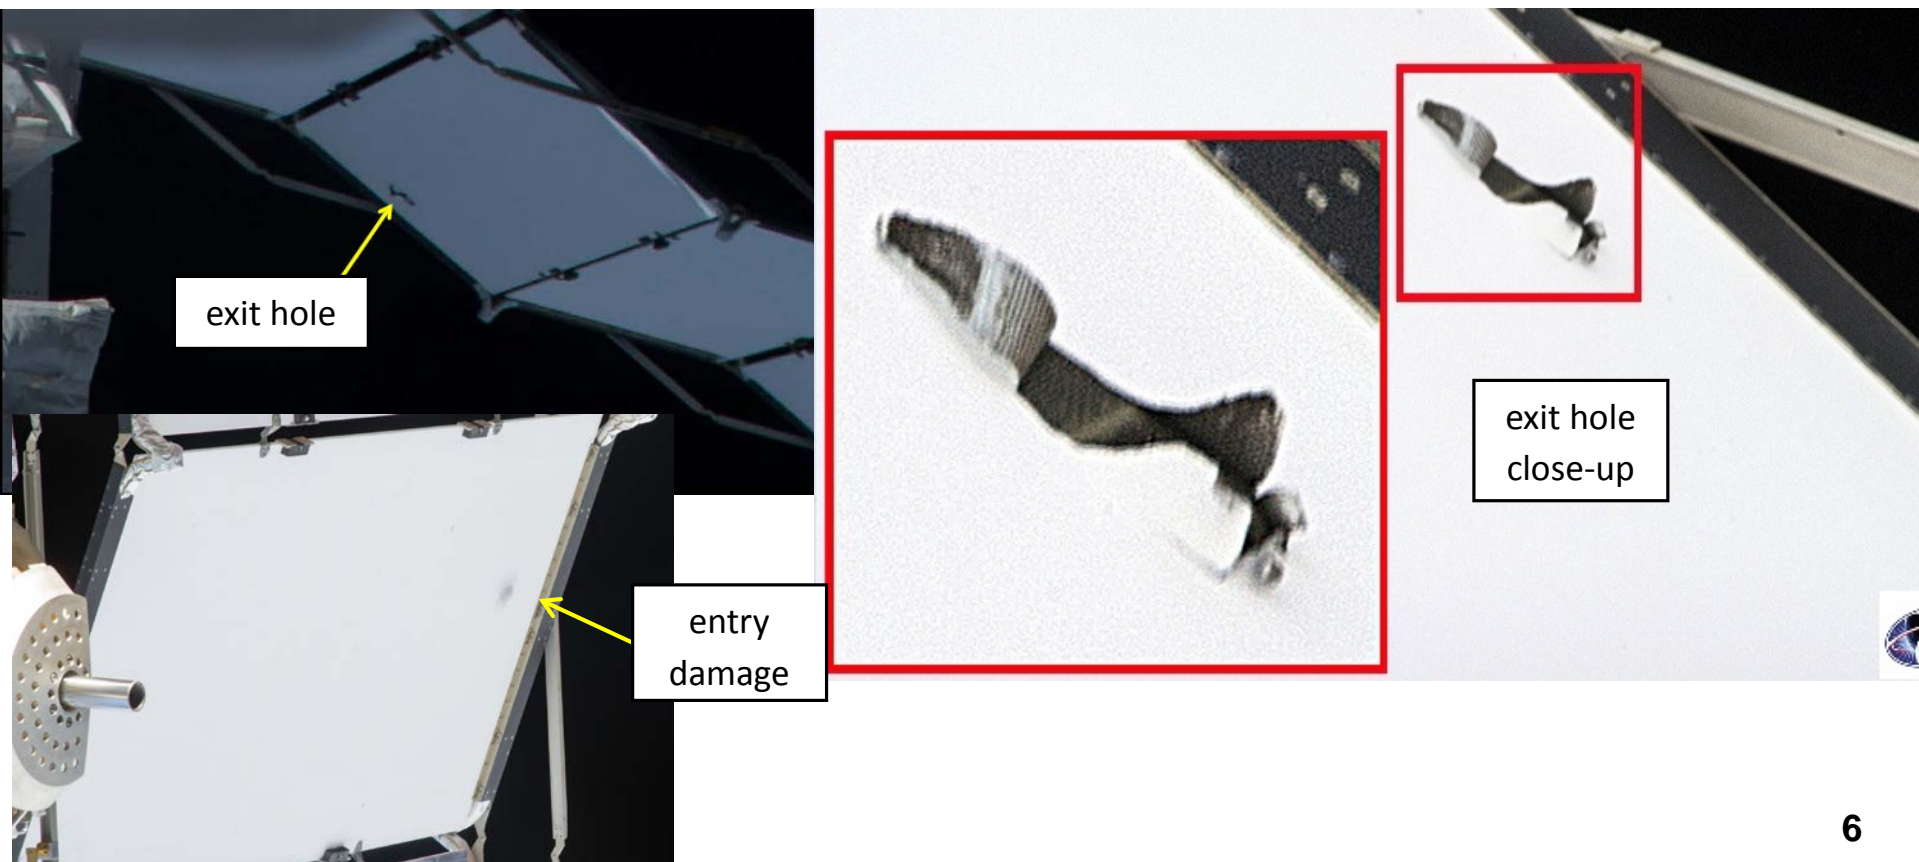
MMOD damage on ISS photovoltaic (PV) radiator

- Indication found on 30 June 2014 (Port 4 truss PV radiator)
- Exit hole shown below measures 5" x 3.9" (13 cm x 10 cm)
- Entry hole on opposite side is 0.7" x 0.5" (1.8 cm x 1.3 cm)
- Initial estimated MMOD particle size causing damage: 4 mm to 5 mm dia.

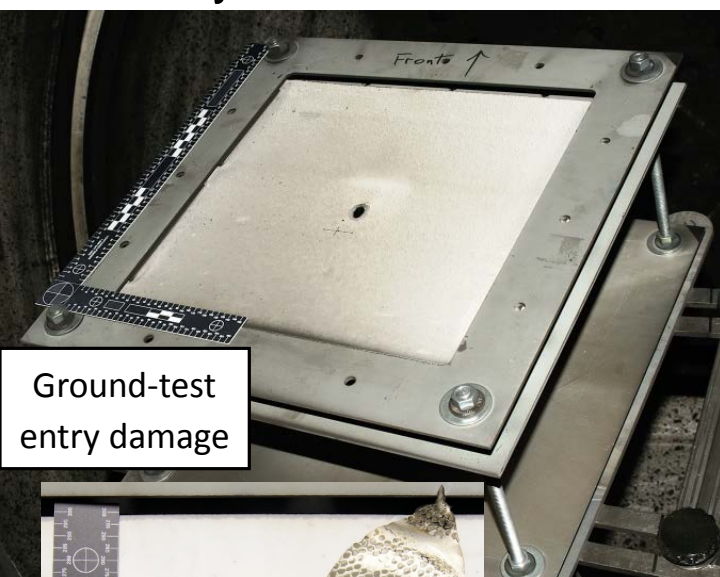
Ground-test
entry damage

- Exit hole damage from 4.5 mm diameter aluminum spherical projectile at 7.08 km/s and 50 deg impact angle (angle from target normal) compares fairly well with actual damage

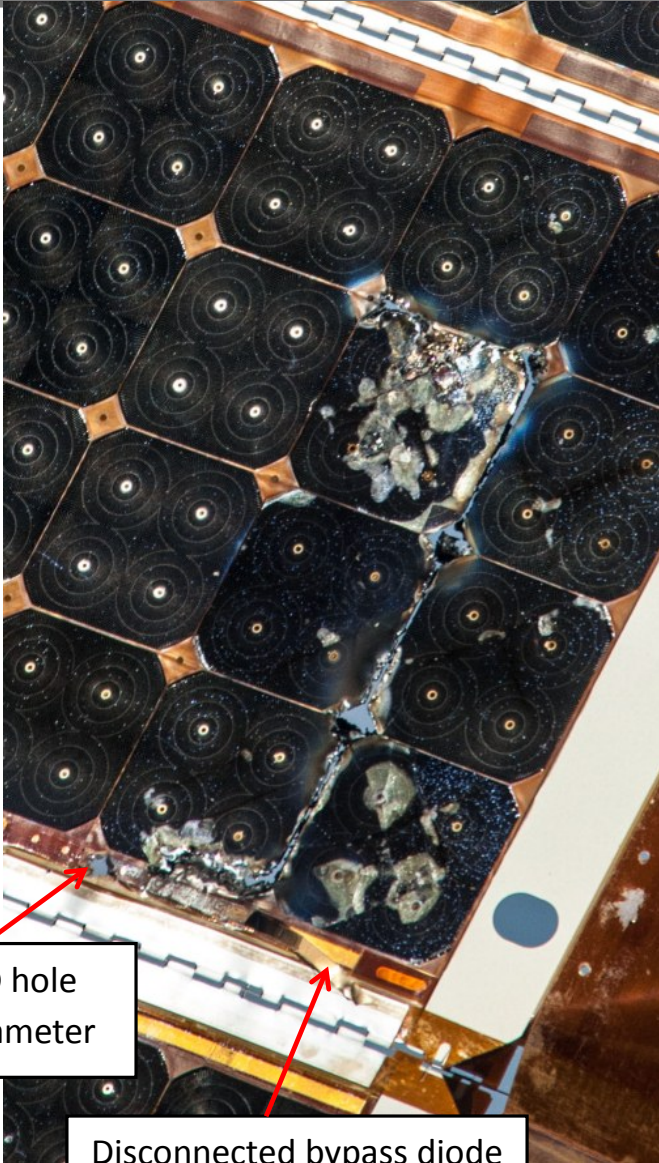
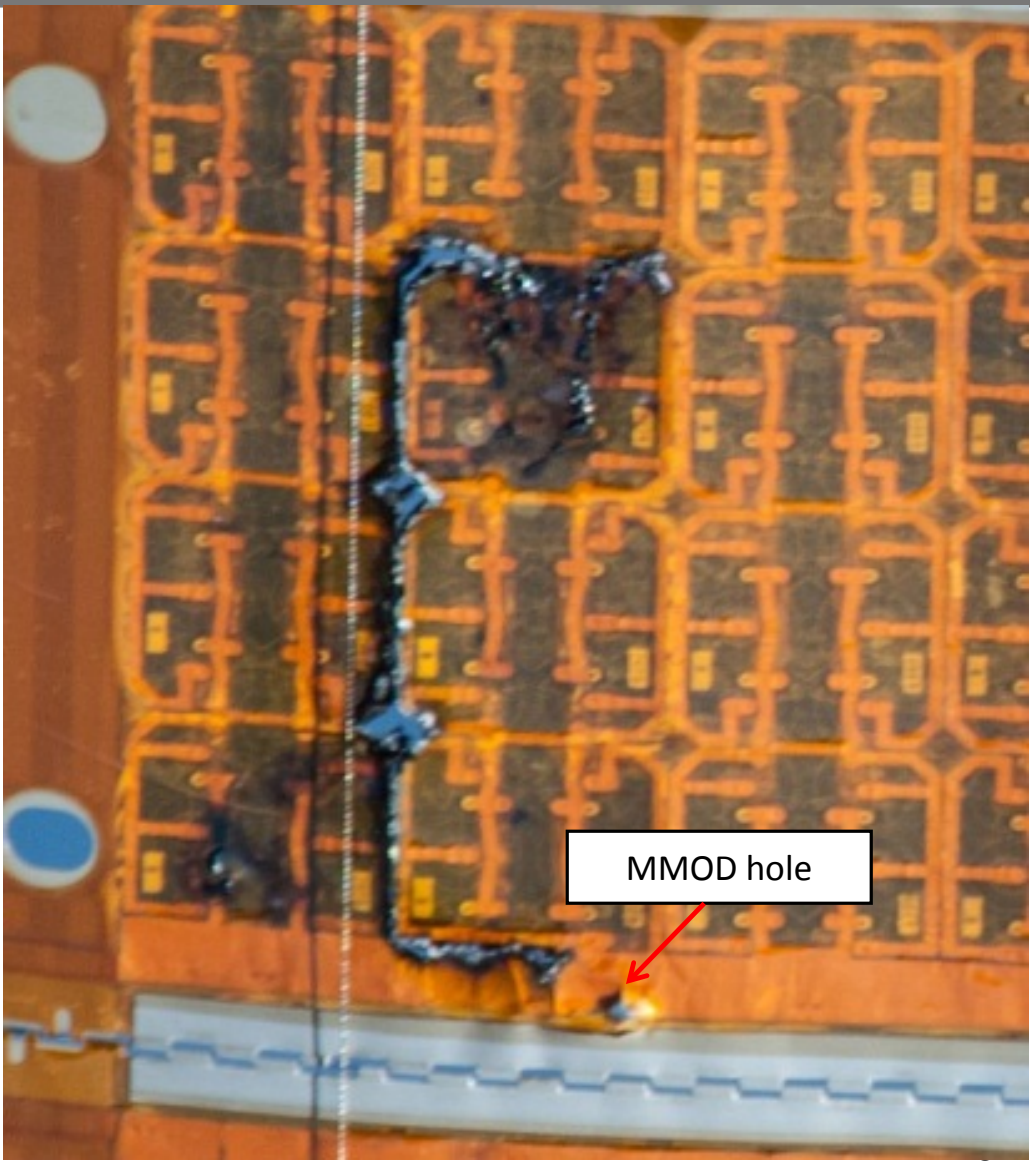
Solar array 3A, panel 58

ISS Solar Array Damage

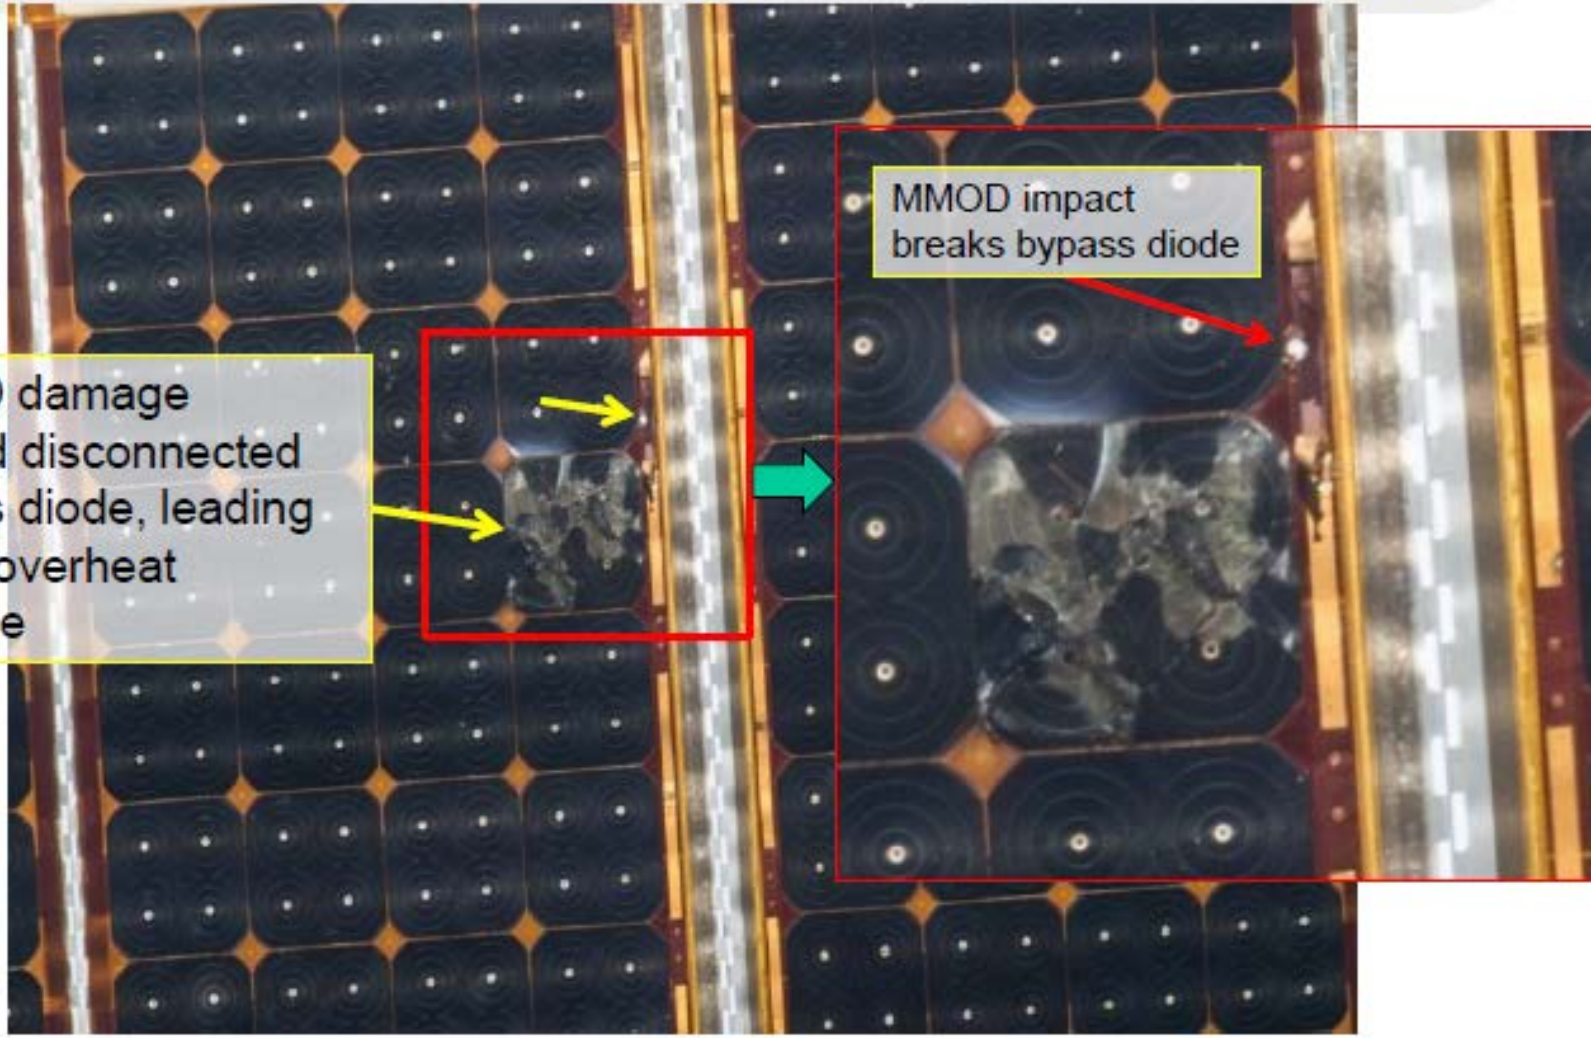
Solar array 2A, panel 66

MMOD damage
caused disconnected
bypass diode, leading
to cell overheat
damage

MMOD impact
breaks bypass diode

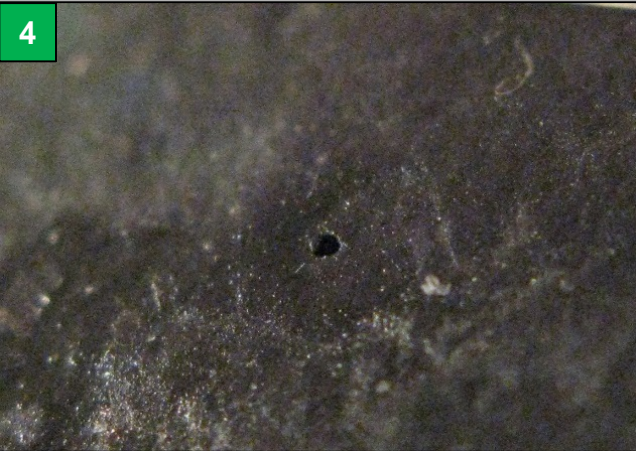
Panel A, Tile 33
Feature Size = 0.51 x 0.50 mm
Depth= 0.50 mm

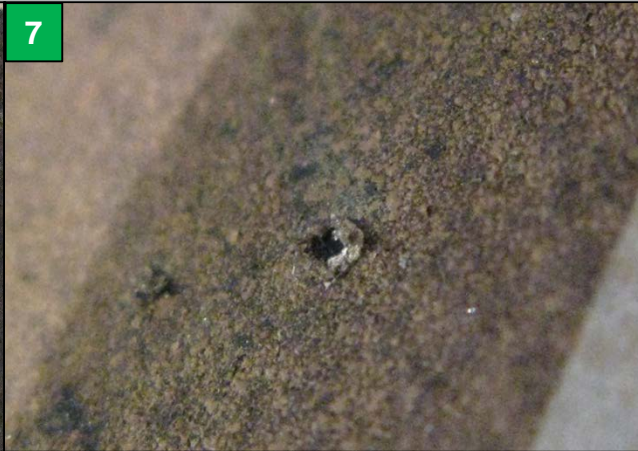
Panel C, Tile 73
Feature Size = 1.29 x 1.10 mm
Depth= 0.05 mm

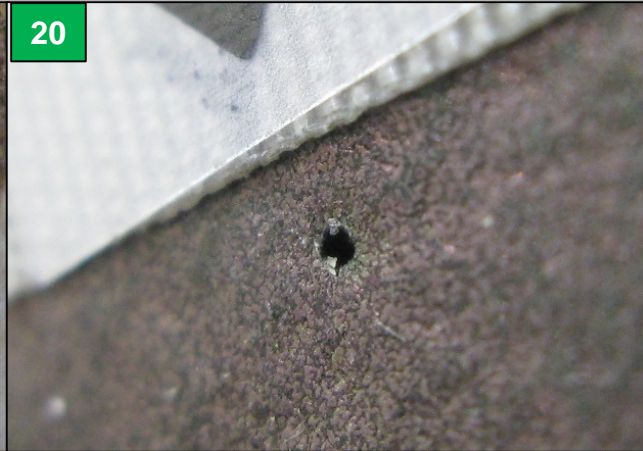
Panel H, Tile 144
Feature Size = 0.63 x 0.56 mm
Depth= 0.54 mm

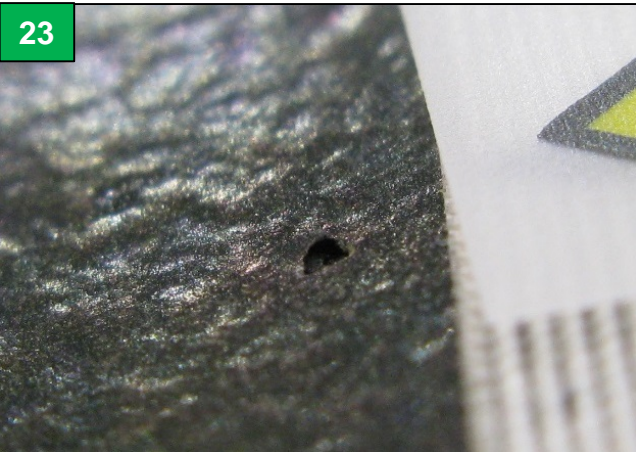
Panel I, Tile 45
Feature Size = 1.18 x 1.15 mm
Depth= 0.60 mm

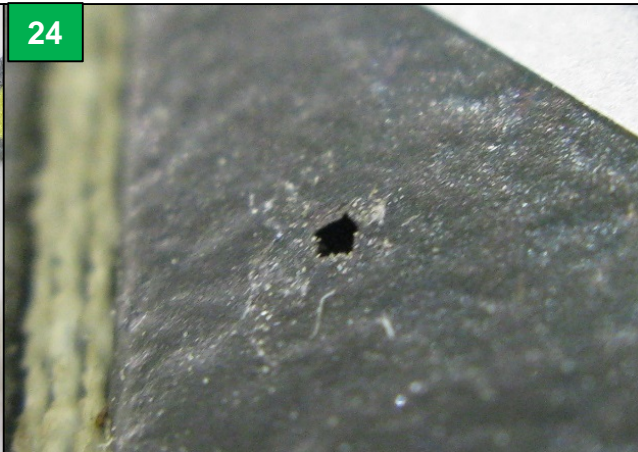
Panel F, Tile 45
Feature Size = 1.06 x 1.02 mm
Depth= 1.02 mm

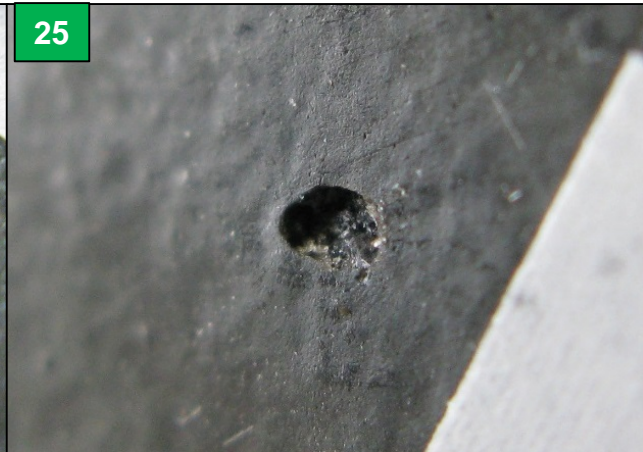
Panel A, Tile 8
Feature Size = 1.88 x 1.27 mm
Depth= 0.70 mm

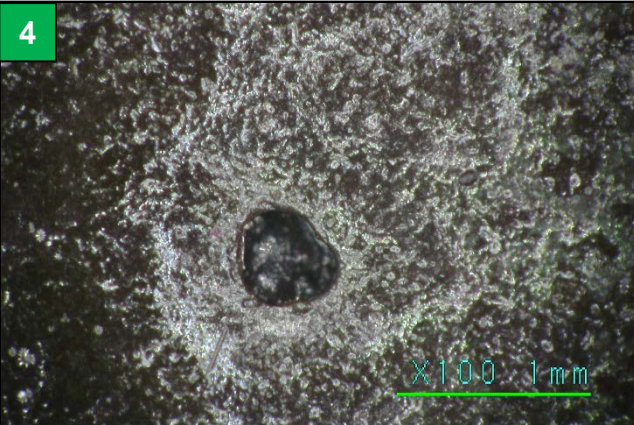
Panel A, Tile 33
Feature Size = 0.51 x 0.50 mm
Depth= 0.50 mm

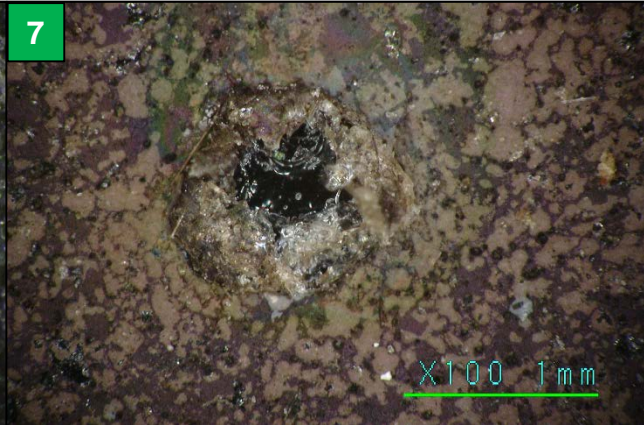
Panel C, Tile 73
Feature Size = 1.29 x 1.10 mm
Depth= 0.05 mm

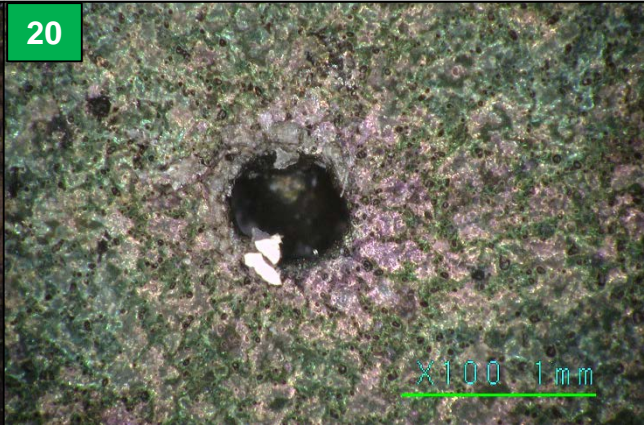
Panel H, Tile 144
Feature Size = 0.63 x 0.56 mm
Depth= 0.54 mm

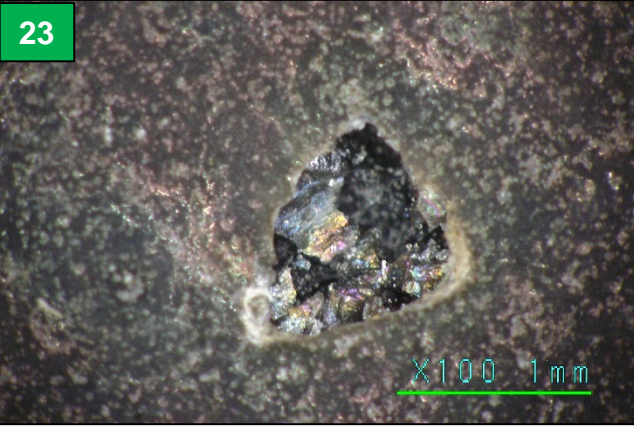
Panel I, Tile 45
Feature Size = 1.18 x 1.15 mm
Depth= 0.60 mm

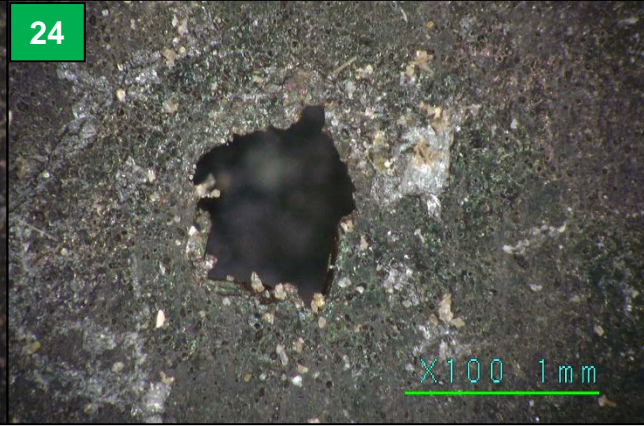
Panel F, Tile 45
Feature Size = 1.06 x 1.02 mm
Depth= 1.02 mm

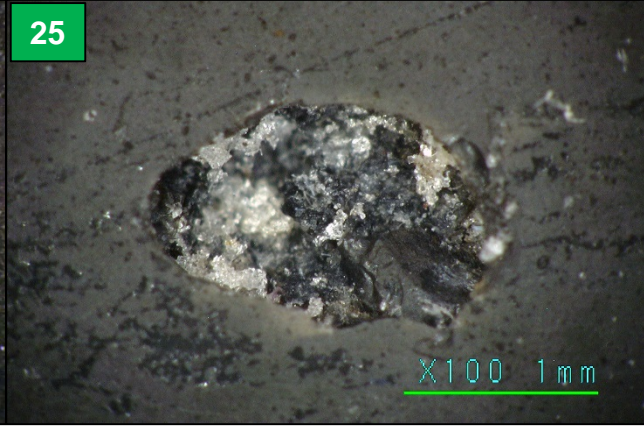
Panel A, Tile 8
Feature Size = 1.88 x 1.27 mm
Depth= 0.70 mm

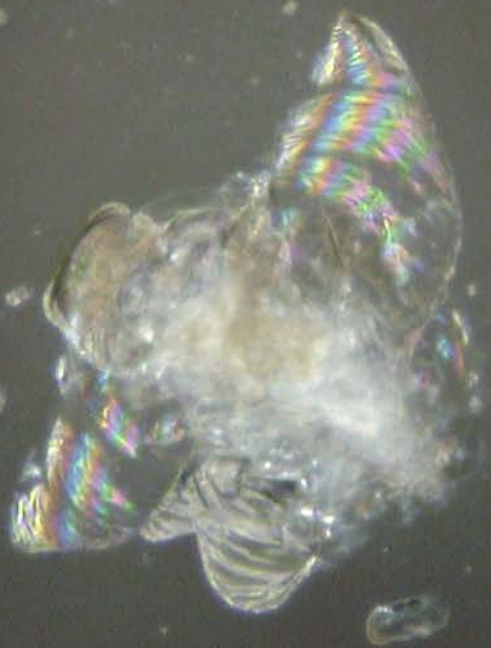
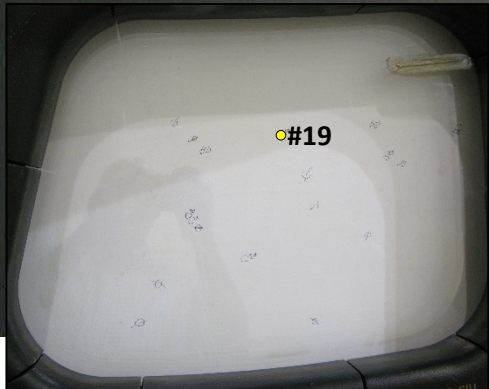
19. +Y Forward

Window impact

Internal Fracture $\approx 0.51 \times 0.41$ mm

Crater $\approx 0.32 \times 0.30$ mm
